**SUBMISSION TO THE NWMB**  
**FOR**  
**An increase to the Cumberland Sound TAH**

Submitted By  
**Cumberland Sound Fisheries Ltd.**

### **Inspection and Valuation of Small Fishing Vessel: Pijiuja II**

Pangnirtung, Nunavut

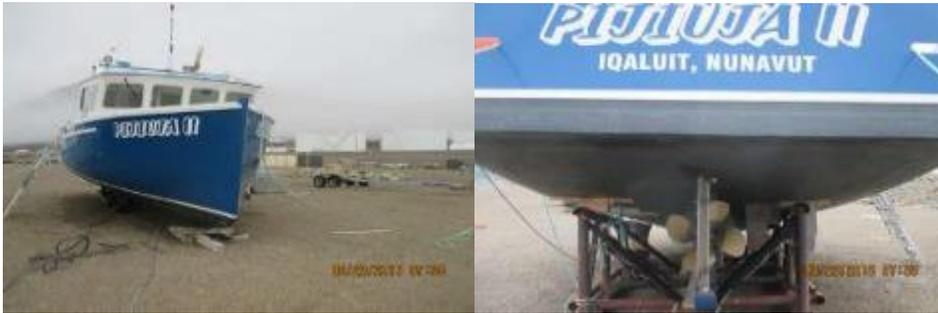
**Photo 1 & 2 (Vessel Profiles)**

The exterior hull and deck was visibly inspected and both were found to be in excellent, like new condition. The vessel has received such little time in-service that no apparent, normal wear and abrasion of several years' vessel activity were visible. The hull below the waterline was inspected and no damage was apparent. Externally, the hull to deck assembly was found to be in excellent condition no distortion apparent in any areas. The original paint has not peeled or worn and there is no evidence of marine growth on the hull. All deck fittings, stem fittings, mooring cleats, life rails, stanchions, hatches, and cleats were inspected and found in good condition. The original corrosion anodes are in excellent condition as well. All deck area, rails and fittings are in excellent condition and are have no visible signs of wear. See photos (1 &2).

- 1.** Twenty Two photographs included in this report document the vessel's current physical condition as in good to excellent. This vessel is less than three years old and has not been in service, except for a minimal amount of time during the 2013 operating season, following delivery. This is evidenced by the fact that there are merely 397.5 actual running hours. This would amount to less than 3 - 4 weeks of actual operation. This is further evidenced by the lack of any marine growth lines that are normally observed on any vessel after an operating season. In its service life, this vessel has never required a hull cleaning.

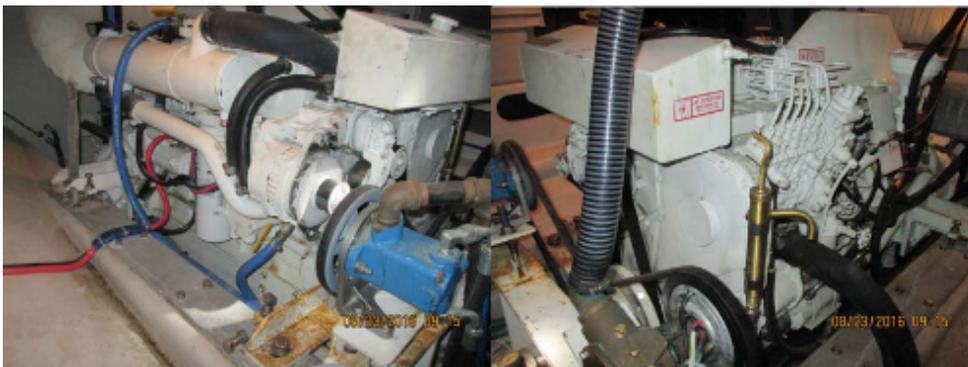
**Photo's 3 & 4 (Engine)**

The vessel is powered by a 300 horse power, Cummins diesel engine that was manufactured and installed in 2013 during the new build process. The engine is in like new condition and has a service reading of 397.5 hours. The manual indicates that this engine should have an initial servicing at 250 hours which was completed and recorded onboard. The engine space is in clean condition with no wear evident, with minimal surface rust.

The engine was de-winterized and prepared for start-up. Initially, it was difficult to perform a start-up, since the battery bank was found to be low of stored power with some battery cells completely dry. When the batteries were replaced, the engine was fired up and running from the first start cycle in mere seconds. The engine ran smooth immediately and ran at the correct operating temperature. The engine compartment is clean and dry and in excellent condition. There are also, available a considerable selection of spare belts and parts as well as fuel and engine filters, that were purchased with the new vessel, that represent good value.

- 2.** The engine and equipment is in excellent condition and has been serviced as required by the manufacturer. Oil and filter changes have been followed as recommended as well. The quick startup, following the insertion of new batteries indicates the engine has no deficiencies. The exhaust stack is constructed of stainless steel and presents in excellent condition, however the stack should be covered for protection during winterization and to prevent leakage from the elements into the engine and engine compartment.

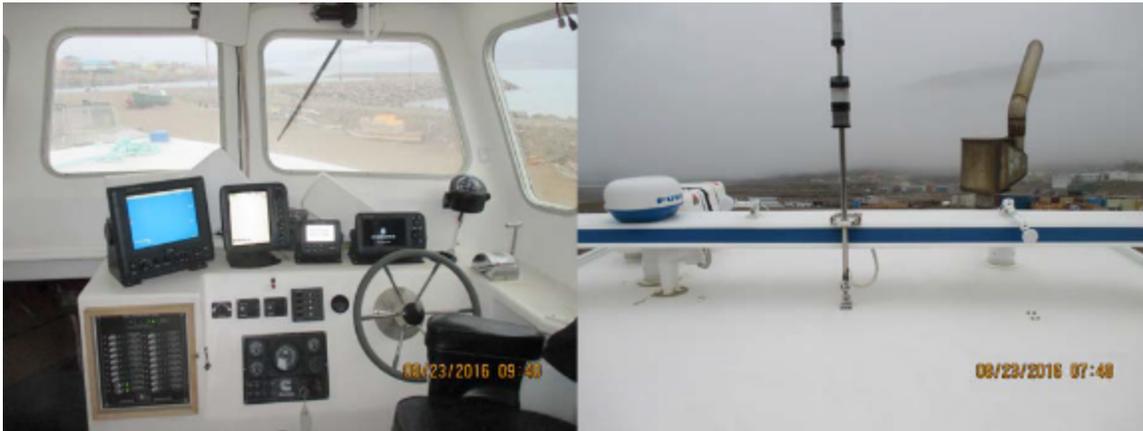
Photos 5 & 6 (Electronic Navigational Equipment with Exterior Appendages)

All of the vessels navigational equipment was powered up and tested. The Charting system, Radar, Sounders and GPS units were all found to be in good working condition when powered. All other bridge console equipment was found to be in excellent condition and in good working order. All appendage fittings for the Radar, GPS units and Transducers were checked and were found to be in excellent condition and in good working order.

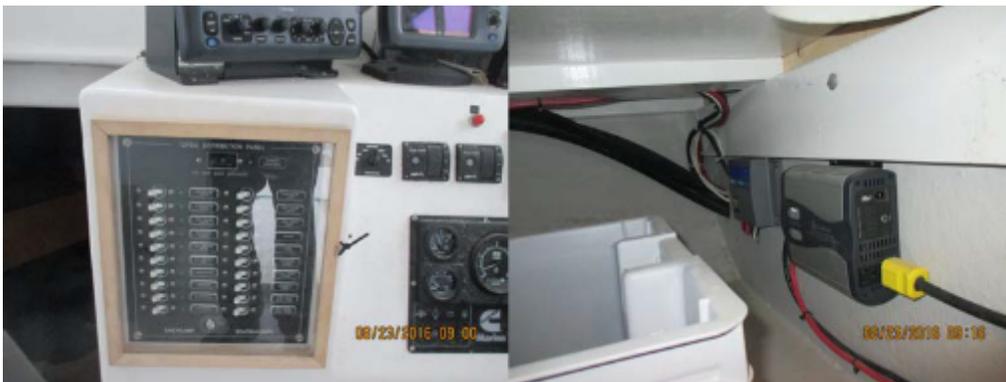
Photos 7 & 8 (Electrical panel and Power Converter)

The vessel's electrical system and equipment was powered and tested, including all navigational lights, cabin lights, gauges and power converters. The electrical panel is like new with no visible signs of damage and all breakers, switches and power outlets were checked and observed as operational.

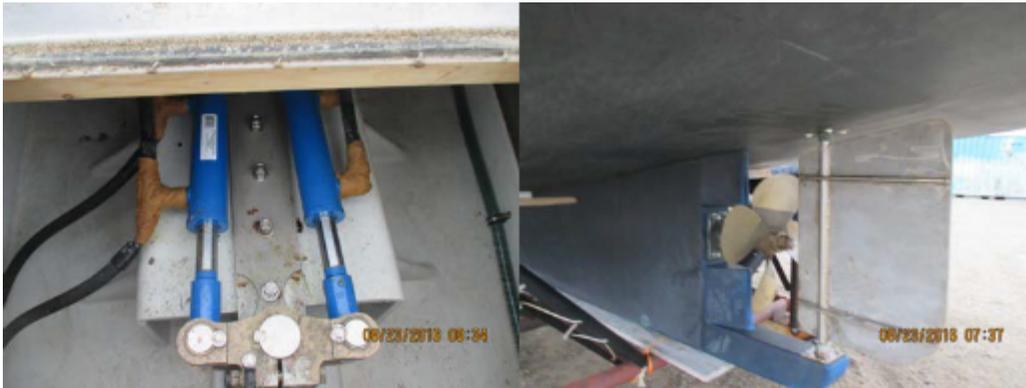
Photo's 9 & 10 Steering Flat and Rudder

The steering and propulsion systems were examined and found to be in excellent condition and both were working freely. The steering flat was clean and steering rams presented as like new. The rudder and assembly presented in excellent condition as well. The propeller blades, shafting and stuffing box also presented as like new condition. There was no visible damage in any of these areas, as evidenced from the pictures below. There is no visible corrosion or rusting to any of the assembly.

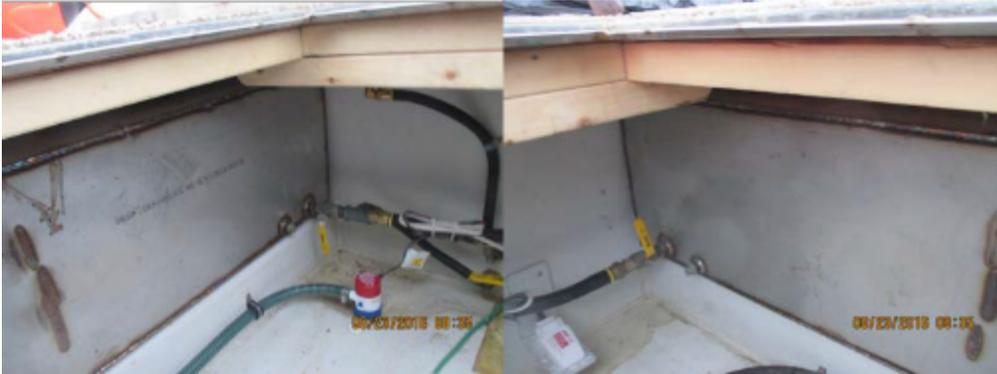
Photo's 13 & 14 (Port and Starboard Fuel Tanks)

The port and starboard fuel tanks were examined and presented as in excellent condition. The tanks are clean, free of rust and both fuel shut offs and tank drains were functional. As well the fuel lines and filters indicate a clean and corrosion free status.

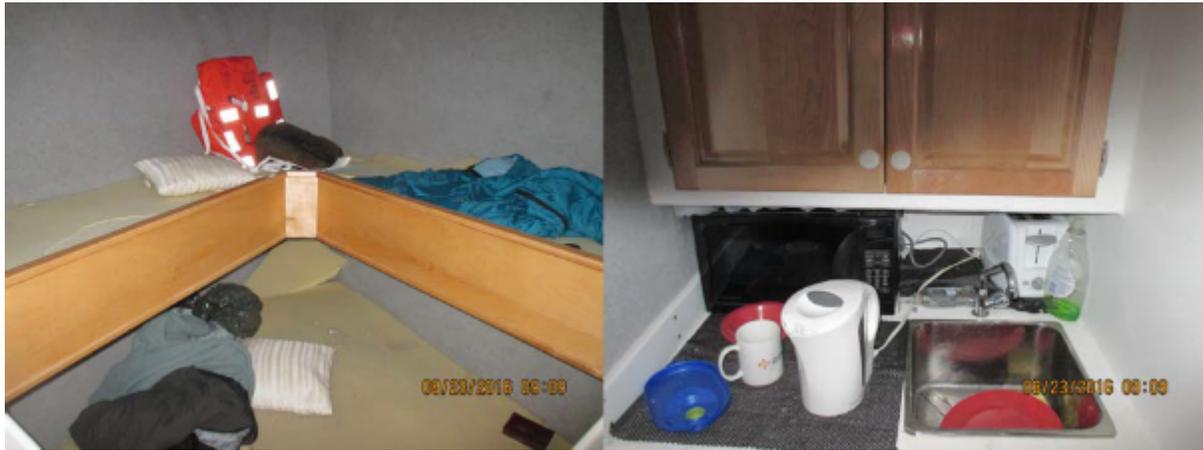
Photo's 17 &18 (Cabin, Bunks and Sink Area)

The internal cabin and bunking area is clean and dry and presents in excellent condition. There is no evidence of any moisture or mildew and the area is as "built".

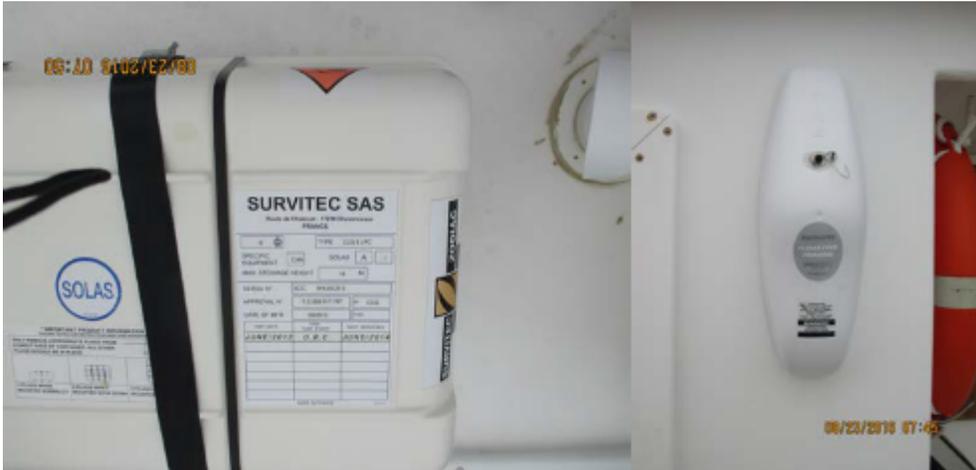
Photo's 19 &20 (Life Raft and EPIRB)

1. One six person life raft which appears to be in good condition, however, the service date is for June 2014, therefore a service re-pack, prior to operating the vessel will be required.
2. Six, universal size, Immersion suits in like new condition; not photographed.
3. One Class I, Float Free EPIRB. This unit is operational and has a battery service date of December 2018.
4. Six Transport Canada approved Life Jackets and Six Personal Flotation Vests. (new condition).
5. One lifebuoy fitted with 27 m of line and two Anchors with 100 metres of chain and rope.
6. Two 4.5 L foam fire extinguishers and one fire bucket.
7. Two First Aid Kits and one Flashlight.

- 4.** All of the safety equipment that requires servicing (life rafts and flares) should identified and be sent out at the seasons end for servicing. This equipment is mostly dangerous goods and it is much more economical to receive certification for the following season via sea freighting.
